**PROCEEDINGS**  
**OF THE**  
**TENTH SYMPOSIUM**  
**ON THE**  
**NATURAL HISTORY OF THE BAHAMAS**

# SMALL HOPE BAY – THE CYCLE OF CASUARINA-INDUCED BEACH EROSION

Neil Sealey  
PO Box N10736  
Nassau, Bahamas

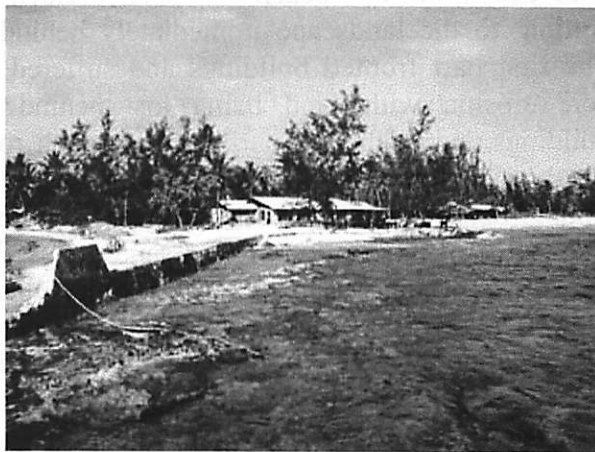
Figure 2. Main area of beach erosion.

As a result of extensive sand loss and damage to buildings it was proposed to construct some form of protection immediately in front of the dining hall, and to undertake longer-term restoration and protection of the area. (Figures 2 and 3)

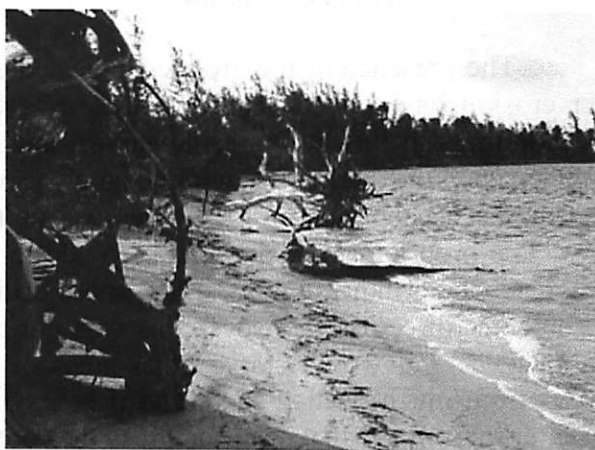
Figure 3. Fallen casuarinas and erosion on south beach.

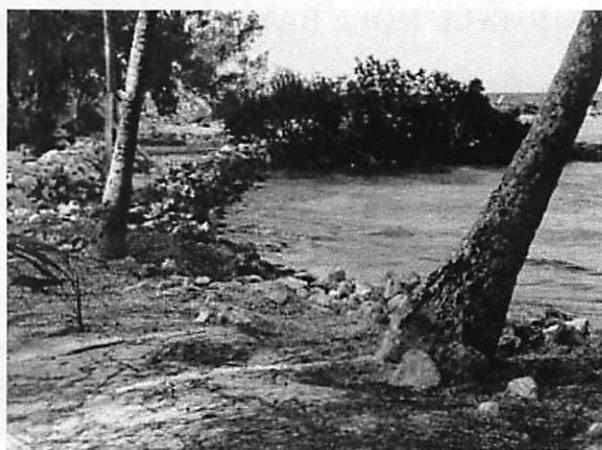
The presence of the groynes indicated earlier erosion having been addressed. Despite this the buildings in this area are threatened, and the collapse of the casuarinas immediately south shows that beach retreat is progressive in this area. The proprietor's response was to add to the groynes, which indicate modest longshore drift in a southerly direction. However this was not recommended as it would starve other areas of the resort from much needed sand, and it is a symptomatic response that will not address the root of the problem, which is chronic sand loss. (Figure 4)

Figure 4. Erosion behind small groyne (in background).

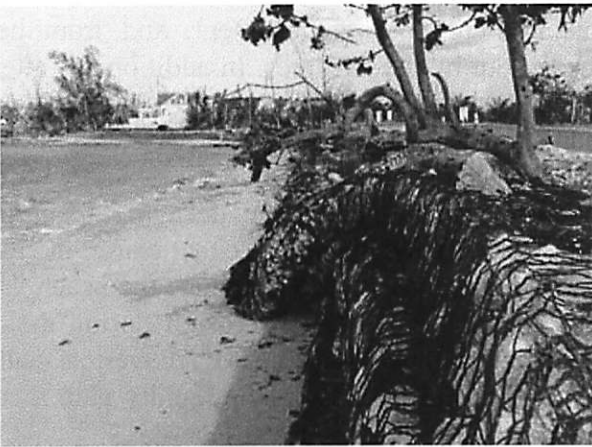
In the critical area in front of the main facilities it was proposed to build a sea wall comprised of gabions. This was strongly advised against and has since been abandoned. Gabions are only suitable in the absence of wave action, such as training walls along river banks. Where they have been installed as sea defences at several places in New Providence and Eleuthera they have totally failed to prevent erosion and have contributed to further sand loss as well as becoming dangerous objects in themselves. Ultimately gabions in stainless steel baskets were used as anchors for rebuilt dunes in the heavily eroded areas, and an attempt has been made to plant native dune vegetation on the new dunes. In themselves these are unlikely to withstand heavy wave action, nor are they likely to build up naturally due to the lack of sand supply at present. (Figure 5).

Figure 5. Collapsed gabion along West bay Street, Nassau, 2002.

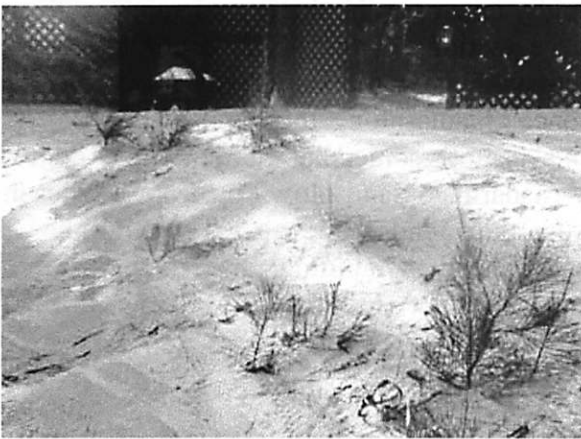
sand. Solid material, if used to anchor rebuilt dunes, would stabilize them in the early stages, and relatively cheap material, such as chopped-down casuarinas, would be adequate. Gabions should also work but seem an expensive and unnecessary solution. Similarly buttressing the rear of rebuilt dunes would be worthwhile, and this has been done successfully with concrete walls in New Providence at the Poop Deck property at Delaporte, which has a similar narrow width of beach with which to work. Vigilance will be needed to prevent the rapid resurgence of casuarina growth. (Figure 6)

Figure 6. Rapid casuarina regrowth in new sand deposit.

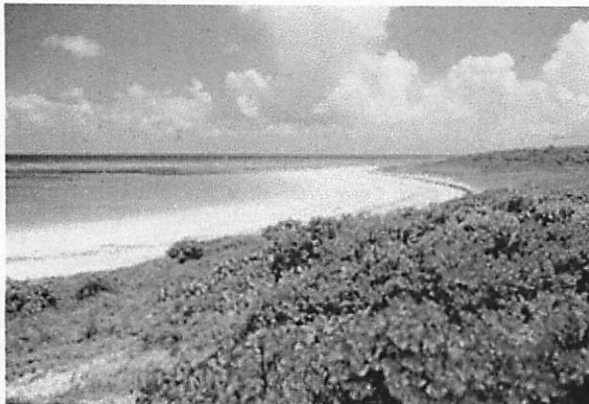
*Stage 2:* Within as little as a season, or as long as several years, the original profile will be regained with the resumed transport onshore of sand from the sea. With abundant vegetation the sand is trapped and with the aid of the wind the dune shore may be progressively widened. Long term monitoring of East Beach on San Salvador by various researchers on San Salvador (Beavers et al, 1995; Brill et al, 1993) shows how a well-vegetated dune encourages prograding, and an annual addition of some 10 000 cu metres of sand per kilometre of beach has been calculated (Anderson & Boardman 1989; Beavers et al, 1995). Recent studies indicate that progradation continues up to the present time, despite beach erosion from hurricanes Lili and Floyd in the intervening years (Godrey, Paul, pers. comm. 2003). (Figures 8, 9)

Figure 9. East Beach and dune on San Salvador, July 1990.

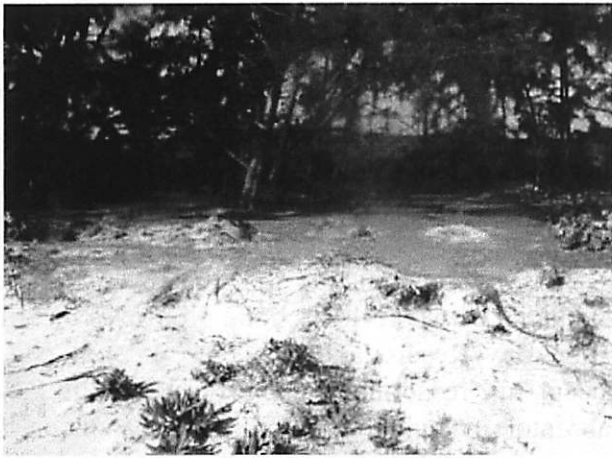
*Stage 4:* This is a quiet stage as far as beach development is concerned. Normal seasonal weather will not impact the beach adversely, but the stage is being set for later destruction. Casuarinas now rapidly take over the dunes and suppress the natural vegetation, completely covering the floor with their twiglets, and leaving only a fringe of native pioneer plants along the exposed foreshore. The dune is now somewhat flattened and dominated by casuarinas. Sand blown up from the beach between tides tends to be carried through the casuarinas instead of building up vertically, hence the flattened effect (Figures 11 and 12).

Figure 12. North beach casuarina invasion, loss of native vegetation and sand moving through trees.

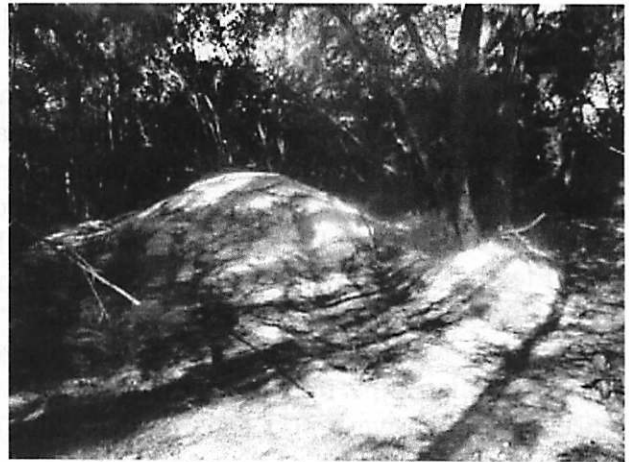
Figure 14. Beach sand piled up at rear of belt of casuarinas on north beach.

Stage 6: The critical stage six has now been reached for continued beach destruction. The sand from the dune has been taken out of the system and dumped behind the trees, in this case in the swamp. With the return of normal weather conditions there is a deficiency of sand to rebuild the beach to its former extent, and the beach retreats landward, threatening all behind it. This is the stage now existing at Small Hope Bay in most areas, with no dunes and a retreating beach dominated by casuarinas (Figure 12). This can be a prolonged stage lasting as long as there is land left to be eroded. With each successive storm the beach shrinks until the casuarina tree line is reached, and fallen casuarinas lying in the sea are the hallmark of this stage, represented at Small Hope Bay by the area immediately north of the resort. Erosion does not stop at the tree line, but continues as the front trees are uprooted and

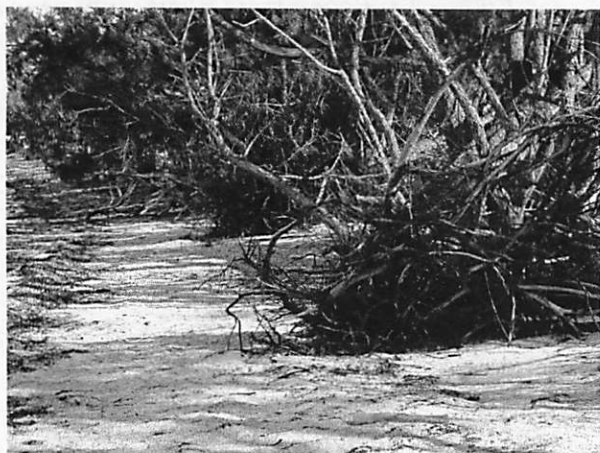
washed away, only to be replaced by more sacrificial casuarinas. (Figures 14, 15 and 16)

Figure 16. Collapsed casuarinas, the final stage, north beach Small Hope Bay 2003.
