**PROCEEDINGS OF THE 12<sup>TH</sup> SYMPOSIUM ON THE  
GEOLOGY OF THE BAHAMAS AND OTHER  
CARBONATE REGIONS**

## THE CYCLE OF CASUARINA-INDUCED BEACH EROSION – A CASE STUDY FROM ANDROS, BAHAMAS.

Neil Sealey  
Bahamas Journal of Science  
Media Enterprises Ltd.  
PO Box N-9240  
Nassau, Bahamas

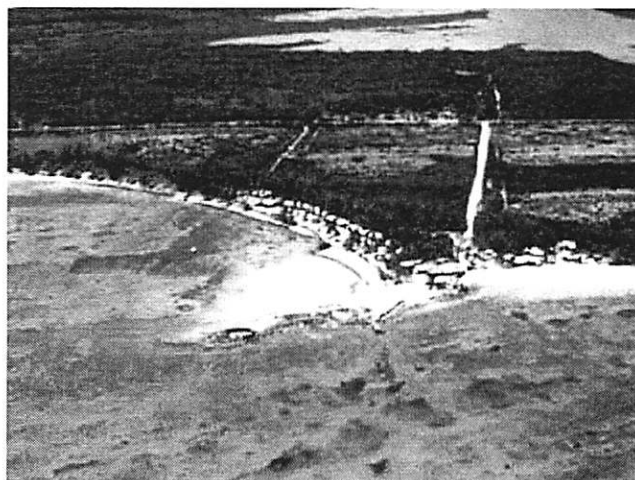
*Figure 1. Aerial view of Small Hope Bay Resort Andros, looking west, with wooden dock projecting from rocky point. Note groyne to left of point.*

Small Hope Bay is located north of Fresh Creek, Andros, on a small low headland with a sandy foreshore extending north and south (Figures 1 and 2). Reports of erosion in this area, and specifically at the hotel property, had been recorded some years before, but after hurricane Michelle in 2001 the situation became critical. As a result of extensive sand loss and damage to buildings it was proposed to construct some form of protection immediately in front of the dining

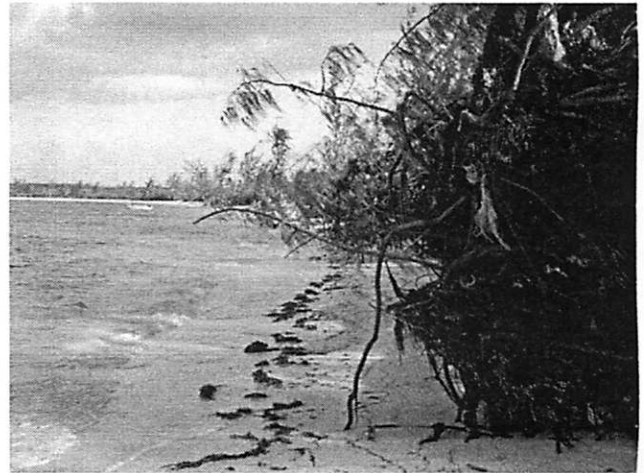
The site was visited in May 2002 and inspected from south to north. The southern section extending away from the property was a narrow beach area littered with fallen casuarinas and other trees, mainly coconut, whose roots pretty much extended to the shoreline (Figure 3). The shoreline in front of the resort's cabins consisted of a number of small bays separated by a short groyne that had clearly been in place for some years (Figure 4). This area was separated from the northern section by a rocky point from which a wooden dock had been extended, and be-

Figure 3. Critical erosion south of resort, beach has effectively been eroded away.

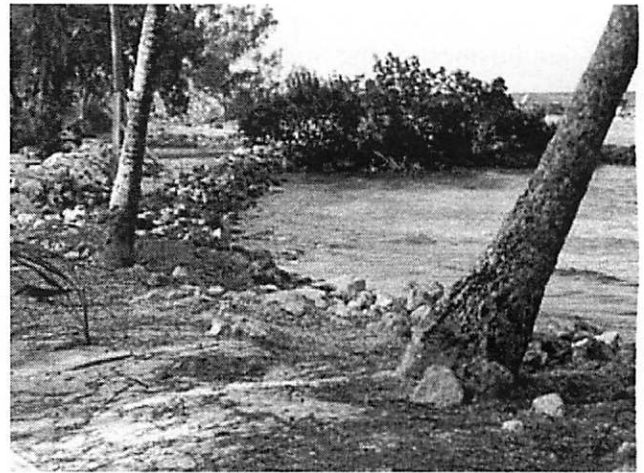
Figure 4. Erosion south of old groyne fronting cabins. This groyne is longer than the others and has been effective in trapping sand.

groyne, which indicate modest longshore drift in a southerly direction. However this was not recommended as it would starve other areas of the resort from much needed sand and it would not address the root of the problem, which is chronic sand loss.

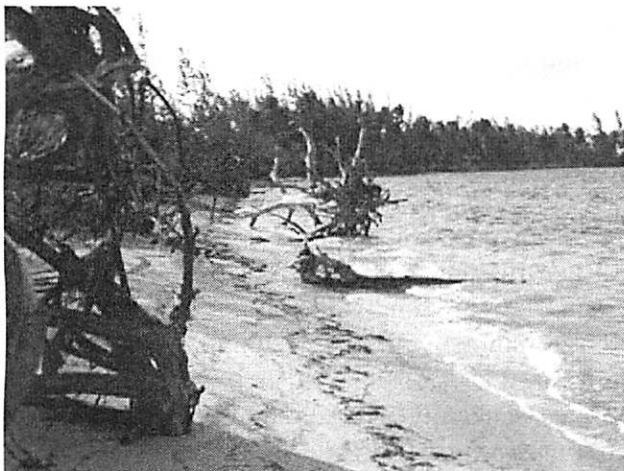
The first part fronted buildings and suffered severe erosion with sand being lost behind the buildings and in the car park and approach road. North of this area was a short section backed by smaller buildings set well back from the shore and also a line of natural but eroded sand dunes. The remainder of the beach extending about a kilometre to the north was backed by mature casuarinas, although at the furthest extremity erosion had caused the collapse of a number of trees (Figure 5). This section terminated at a rocky headland.

*Figure 5. Main area of beach erosion north of resort.*

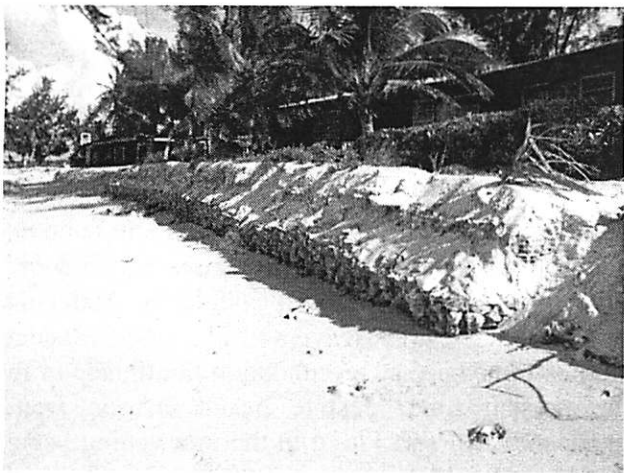
*Figure 6. Rebuilt sand dune with young vegetation showing resistance to summer wave action.*

Eleuthera they have totally failed to prevent erosion and have contributed to further sand loss as well as becoming dangerous objects in themselves. Ultimately gabions in stainless steel baskets were used as anchors for rebuilt dunes in the most heavily eroded areas, and an attempt has been made to plant native dune vegetation on the new dunes. In themselves these are unlikely to withstand heavy wave action, nor are they likely to build up naturally due to the present lack of sand supply. Despite this, it is a constructive step, and in conjunction with casuarina removal will aid in the stabilization of the shoreline (Figure 6).

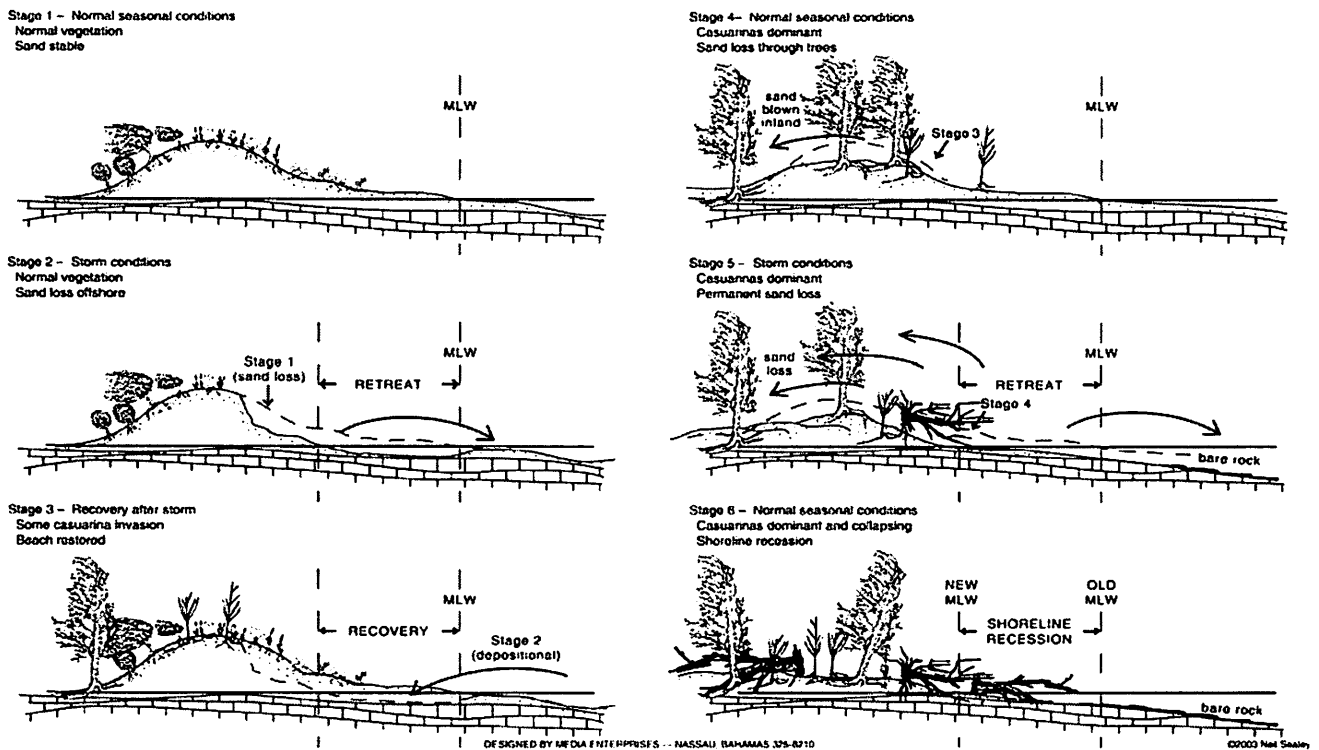
Casuarina-Induced Beach Erosion (Figure 7) by way of a schematic set of stages, each one matched to their presence at Small Hope Bay. If casuarinas are present along a sandy shoreline the stage in the cycle can be identified and therefore the future erosional history of the beach can be forecast.

Figure 7. The six stages of the Casuarina-Induced cycle of beach erosion ending in the perpetual state of continued beach recession.

This represents the first stage of the cycle, prior to casuarina invasion. There is only a small portion of this stage left at Small Hope Bay, just south of the main buildings (Figure 7).

In times of heavy seas the beach sand is washed offshore and the front of the sand dune eroded. As the sand is merely moved out into the bay it returns with the resumption of seasonal weather, and is again fixed in the dune by native species of dune vegetation, and the beach is thus built up by normal wave action. Within as little as a season, or as long as several years, the original profile will be regained and transport of sand from the sea bed to the shore will be resumed. With abundant vegetation the sand is trapped and with the aid of the wind the beach may be progressively widened. Long term monitoring of East Beach on San Salvador by various researchers on San Salvador (Beavers et al., 1995; Brill et al., 1993) shows how a well-vegetated dune encourages prograding, and an annual addition of some 10 000 cu metres of sand per kilometre of beach has been calculated (Anderson & Boardman 1989; Beavers et al., 1995). Recent studies indicate that progradation continues up to the present time, despite beach erosion from hurricanes Lili and Floyd in the intervening years (Godfrey, Paul, pers. comm. 2003) (Figure 8).

With the introduction of casuarinas after recovery from storm damage some of the dune vegetation is lost due to competition for nutrients in this nutrient poor environment, and from being shaded out by the tall trees. In addition the litter of branchlets further inhibits the growth of young plants by smothering them (Hammerston 2001). There is also some evidence of a toxic effect from the root system and/or the decaying plant litter (Craig, 1978). Whatever the exact cause, the result is that casuarinas start to dominate the beach vegetation. With severe beach erosion during a storm the dune is now less able to recover its natural vegetation and the casuarinas rapidly gain a commanding foothold.

opment is concerned. Normal seasonal weather will not impact the beach adversely, but the stage is being set for later destruction. Casuarinas now rapidly take over the dunes and suppress the natural vegetation, completely covering the floor with their twiglets, and leaving only a fringe of native pioneer plants along the exposed foreshore. The dune is now somewhat flattened and dominated by casuarinas. Sand blown up from the beach between tides tends to be carried through the casuarinas instead of building up vertically, hence the flattened effect (Figure 9).

Stage five results from the first severe storm after the takeover by casuarinas. Waves strip down the beach and pound the dune but the dune is now lower and consists of bare sand dominated casuarina trees. As well as sand being washed offshore, and there will be much more of

it exposed to wave action than when covered by native plants, the sand will also be washed through the trees and end up behind them. The result is the total removal of the dune system and the familiar exposure of casuarina roots. This is the situation all along the southern section of

beach at Small Hope Bay, and also why the sand was washed through the buildings and access road during Michelle. Inspection of the casuarina stand north of the resort showed masses of sand carried through the trees and dumped in the swamp (Figure 10).

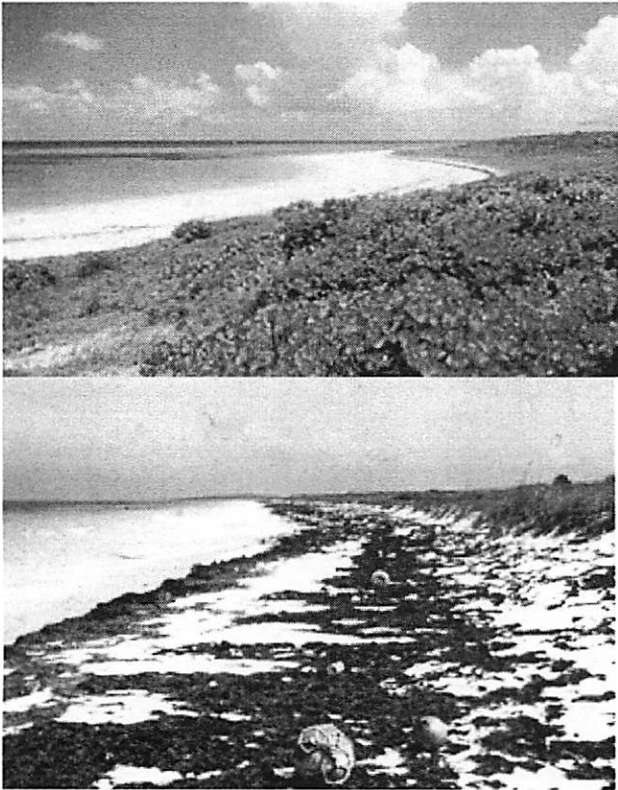
Figure 8. East Beach and dune on San Salvador, July 1990. Note absence of casuarinas.

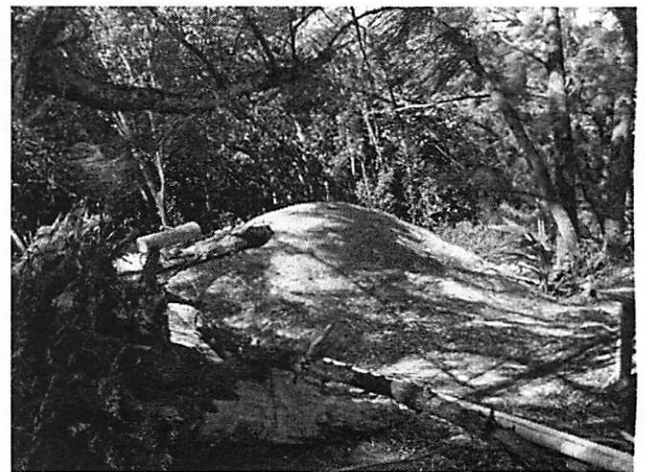
Figure 10. Beach sand piled up at rear of belt of casuarinas on north beach.

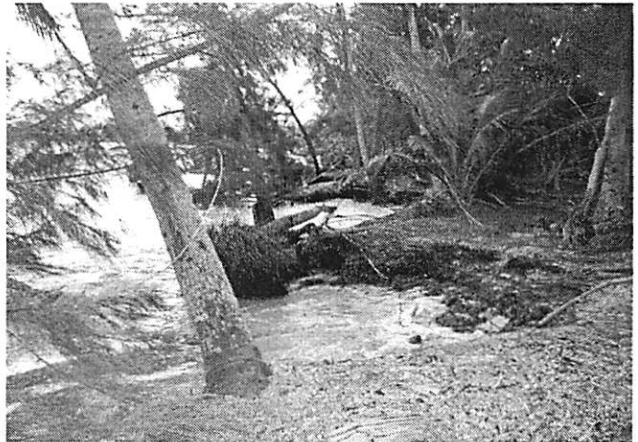
*Figure 12. Detail of shoreline erosion in same area as Figure 11.*

The Small Hope site was revisited in 2003 and 2004. Continued loss of the shoreline was evident, most notably to the south. In the space of 18 months there was evidence of as much as six metres of shoreline retreat judged by the position of trees now in the sea that were previously on the beach. (Figures 11, 12) This is despite the absence of abnormal weather conditions over the last two years. At the far end of the northern beach conditions were similar but less extreme. Mitigation had been achieved in two areas, the section of rebuilt dune and the area of north beach closest to the resort. In the latter area the proprietor had begun bulldozing the casuarinas and already native species were colonizing the exposed sand. Nevertheless vigilance will be required to uproot young

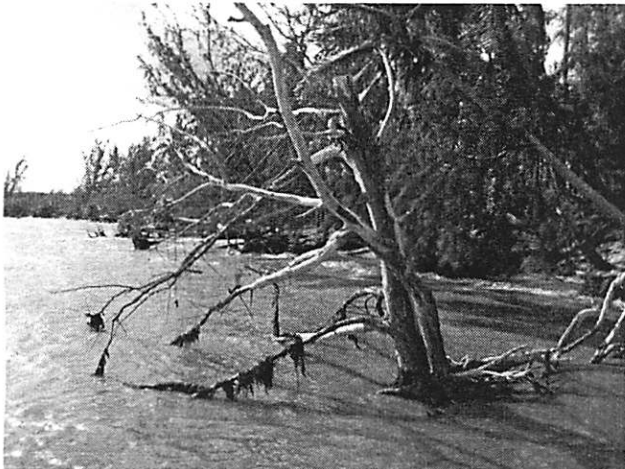
*Figure 11. Accelerated erosion with collapse of casuarinas and rapid shoreline regression, 2004.*
